AGENDA ITEM 9I

SUBJECT: Consideration of Addendum No.1 to Final Environmental Impact Report on

State Water Interconnection Project

ADDENDUM NO. 1 TO THE CITY OF SAN BUENAVENTURA STATE WATER INTERCONNECTION PROJECT CERTIFIED ENVIRONMENTAL IMPACT REPORT

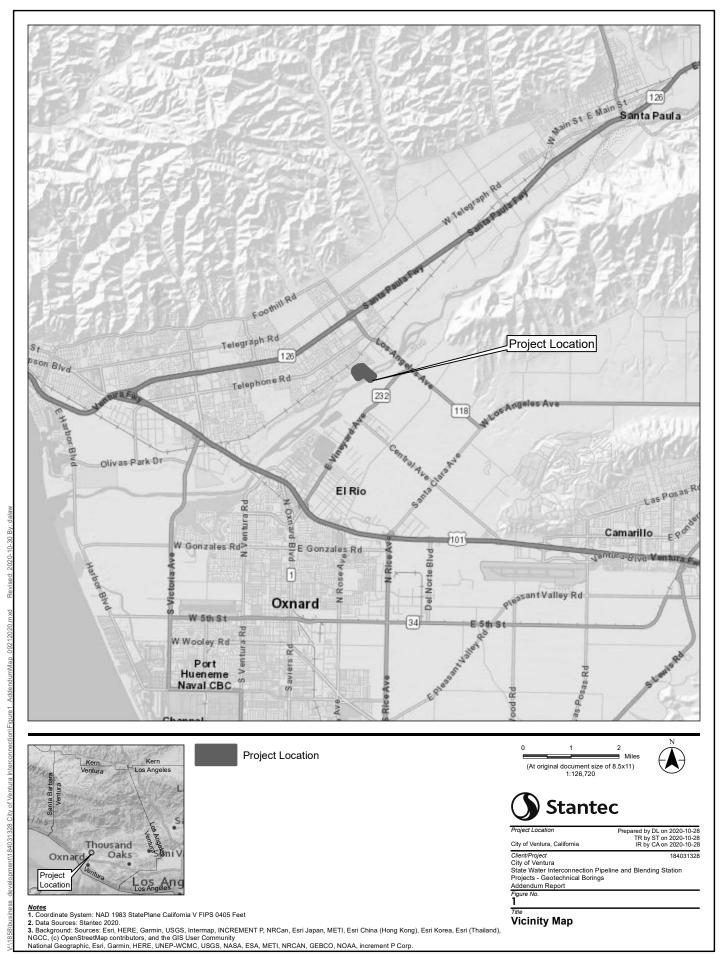
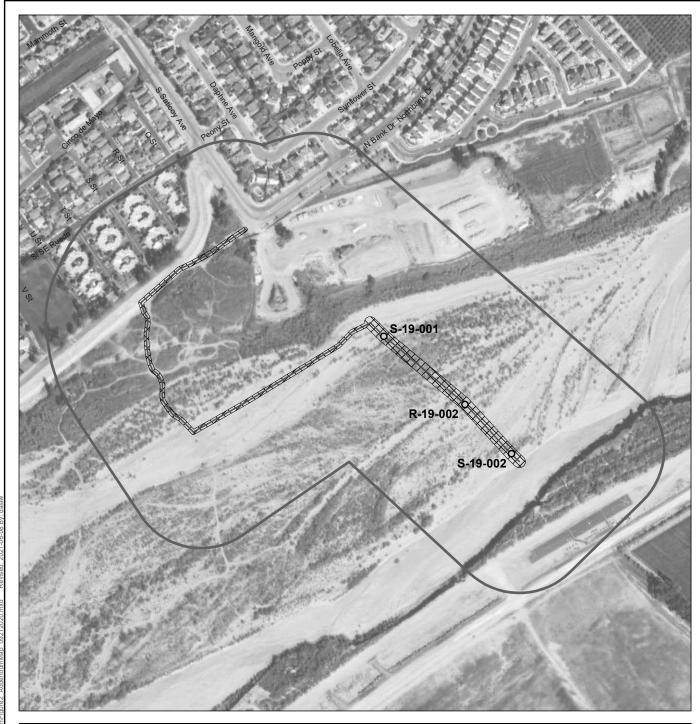
Note: Proposed soil boring locations are shown in an approximate location. Final locations will be determined based on field conditions that are unknown at this time.

The approximate boring locations presented in Figure 2 are subject to minor modification based on physical and environmental conditions observed during pre-boring environmental surveys and which occur at the time of drill rig mobilization. Several drilling methods may be utilized, including mud rotary, air rotary, sonic drilling, and rock coring. The primary equipment anticipated to be used for drilling boreholes includes the following:

The geotechnical investigation component of the Project is located within the Santa Clara River, its banks, and adjacent uplands within the County of Ventura (County), as shown in Figure 1 and Figure 2. Existing conditions of the Project area are the banks and bed of the Santa Clara River. The approximate Project location may include the following County Assessor's Parcel Numbers: 129002006, 129001136, 128011022, 128004029, 128004033, 129002003, and 108004005. The northern boundary of the study area is southeast of North Bank Drive approximately along its intersection with Saticoy Avenue. The southern boundary of the study area is approximately 0.4 mile north of East Vineyard Avenue, north of an agricultural area and undeveloped field, as well as a radio control model airplane runway.

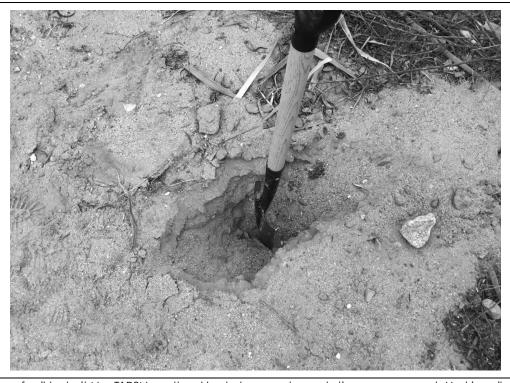
Photo 1: October 8, 2020

View of soil test pit No. T1P3N; wetland hydrology and vegetation were present. Hydric soils not observed however this location met the hydric soil requirement per conditions in the Arid West Supplement

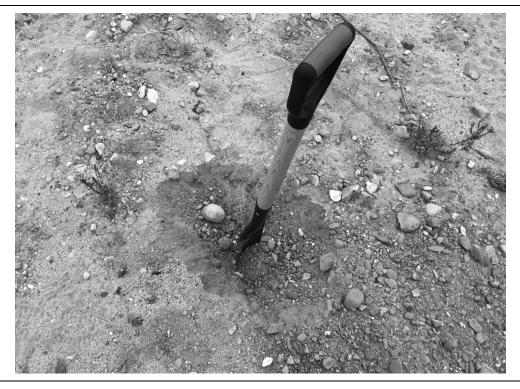
Photo 3: October 8, 2020

View of soil test pit no. T3P2N; no wetland criteria were met at this location.

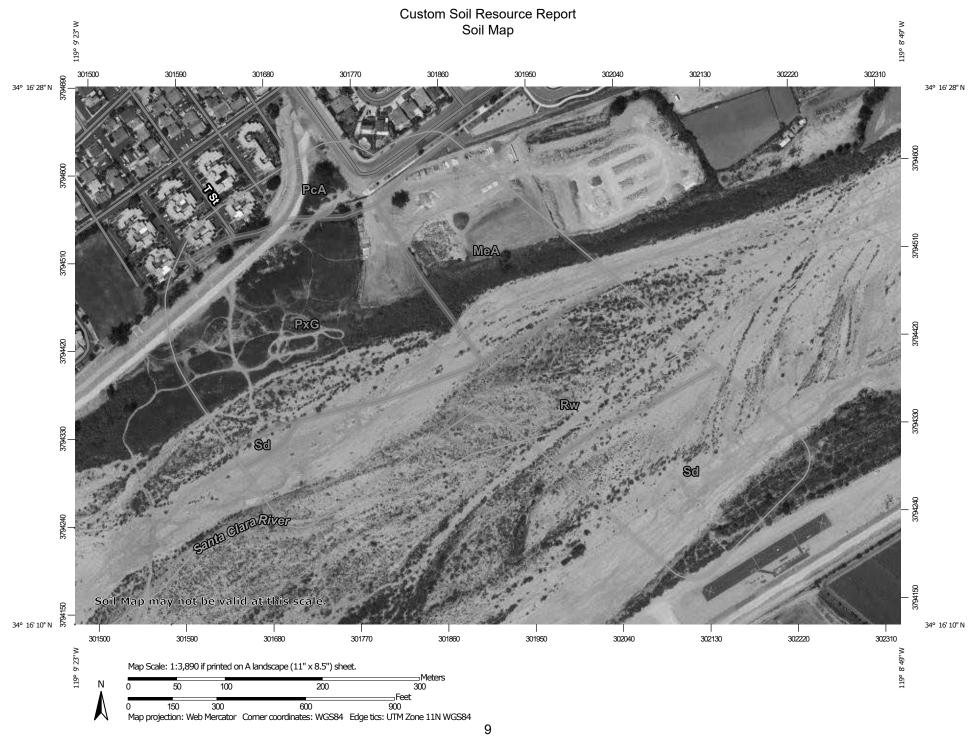
Soil Map

The soil map section includes the soil map for the defined area of interest, a list of soil map units on the map and extent of each map unit, and cartographic symbols displayed on the map. Also presented are various metadata about data used to produce the map, and a description of each soil map unit.

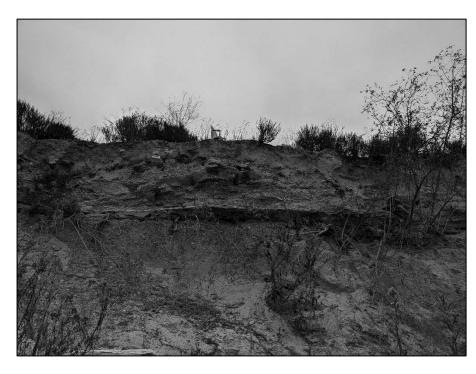
Figure 4. Numerous river terrace levels and erosional surfaces observed along the southern bank of the Santa Clara River, view southeast. Photo taken on October 8, 2020.
