### SmartBall Inspection of Oxnard-Santa Rosa Feeder

Purveyor Managers Meeting January 23, 2025

Calleguas Potable Water System
Condition Assessment of Bar-Wrapped Pipe (AWWA C303)
System Modifications
Smart Ball Inspection (OSR 1 & 2)

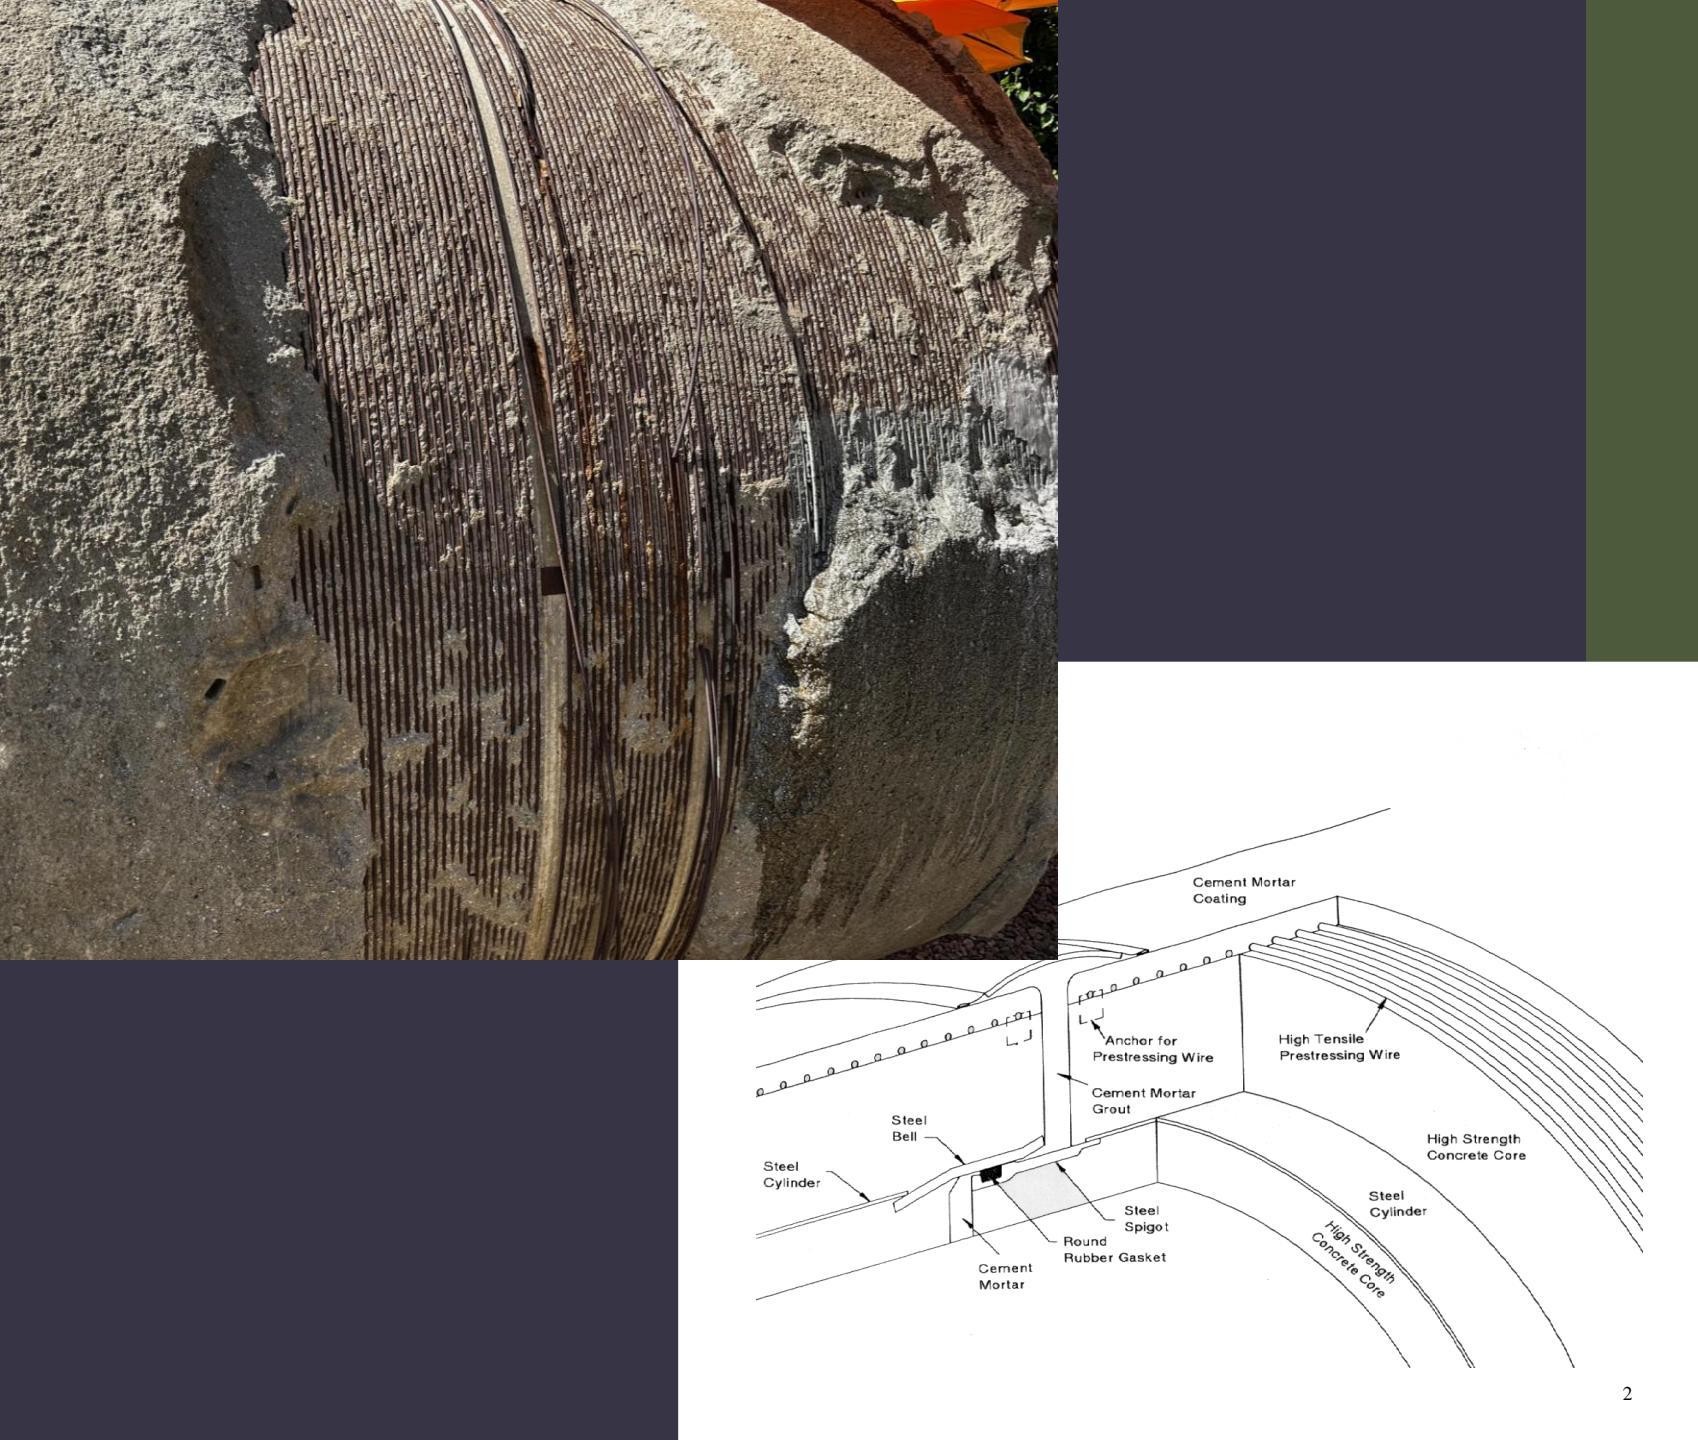
Prestressed Concrete Cylinder Pipe High-strength concrete core Steel cylinder High-tensile prestressing wire

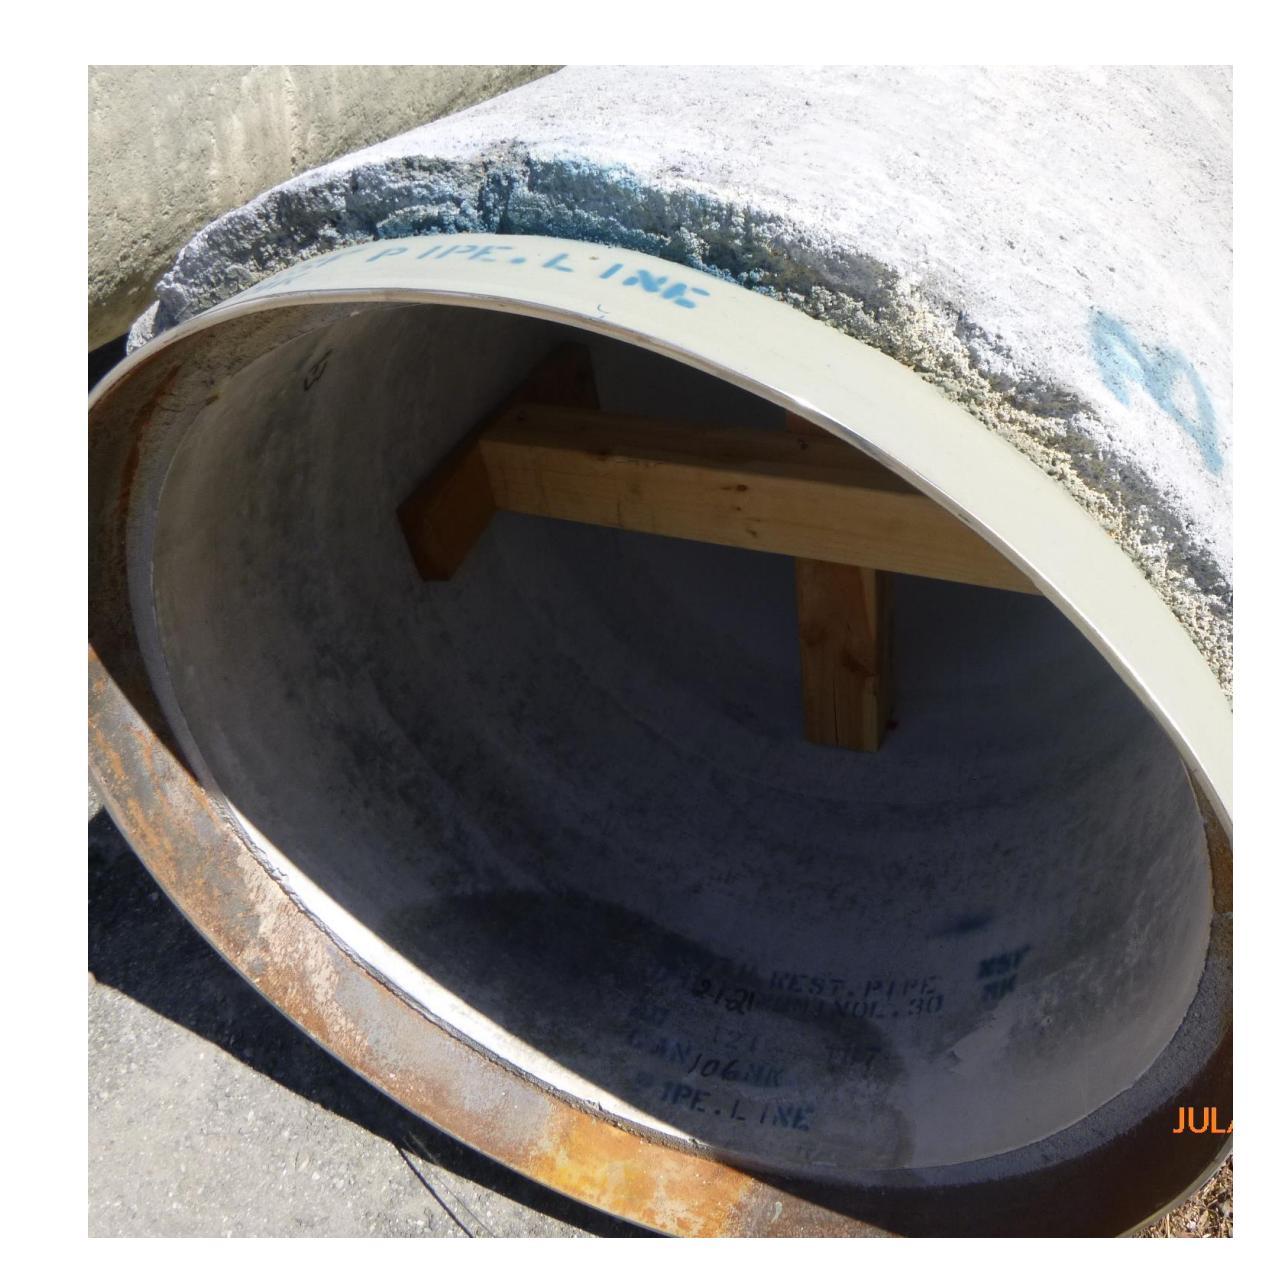
#### Welded Steel Pipe

- Thick steel cylinder
- Lined and coated with mortar

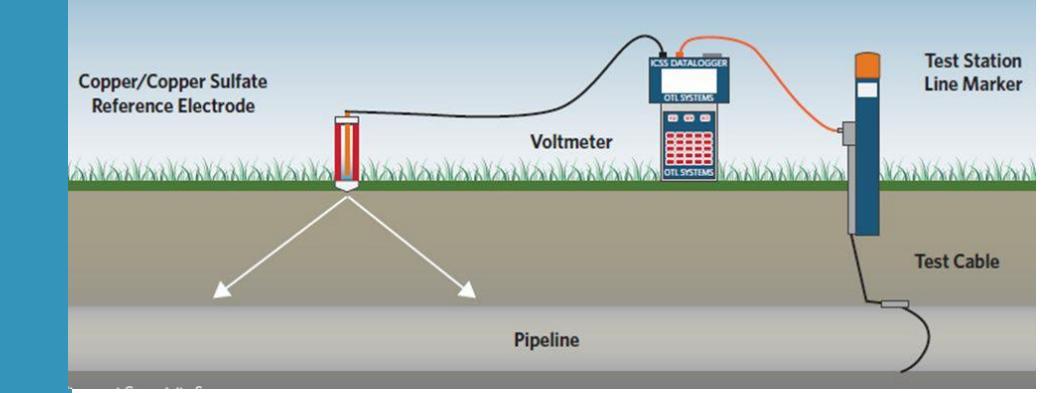
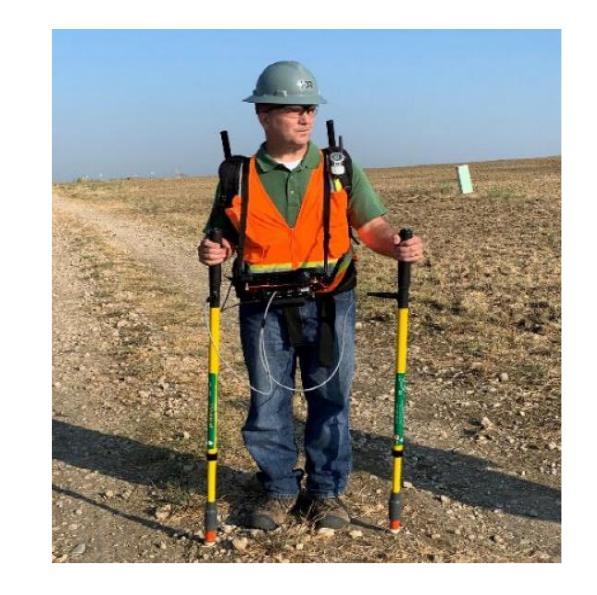
#### Close Interval Surveys

- Pipe-to-soil survey – potential readings between the pipeline and electrode.

- Cell-to-cell survey – readings between electrodes above pipeline.

- In both cases, electrode needs to make contact with the soil.

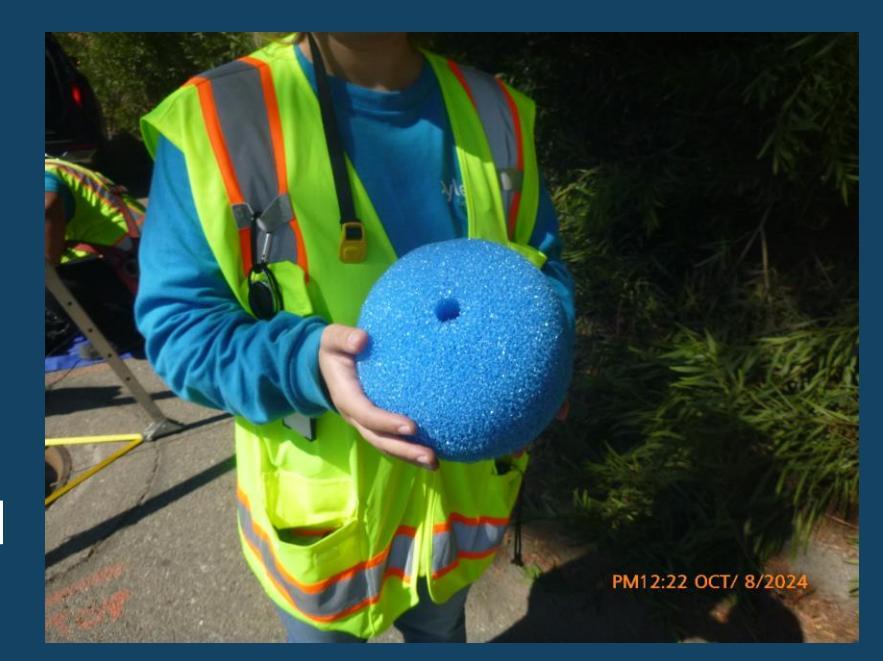
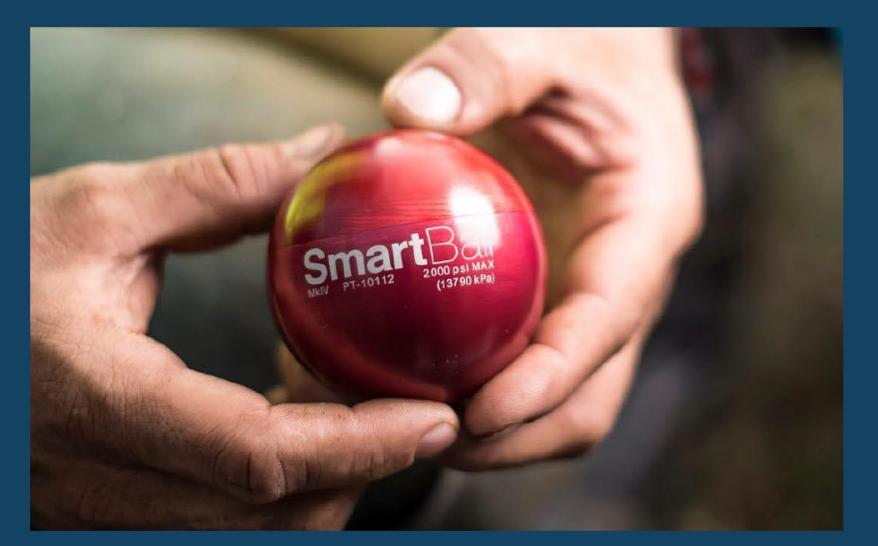
### Leak Detection Survey

In-pipe leak detectors "listen" for leaks as they are transported by water along a pipeline.

- Tool is inserted into a pipeline while in service
- Requires access port for insertion and extraction of tool
- Neutrally buoyant tool flows along centerline
- Min and max flow velocities are required

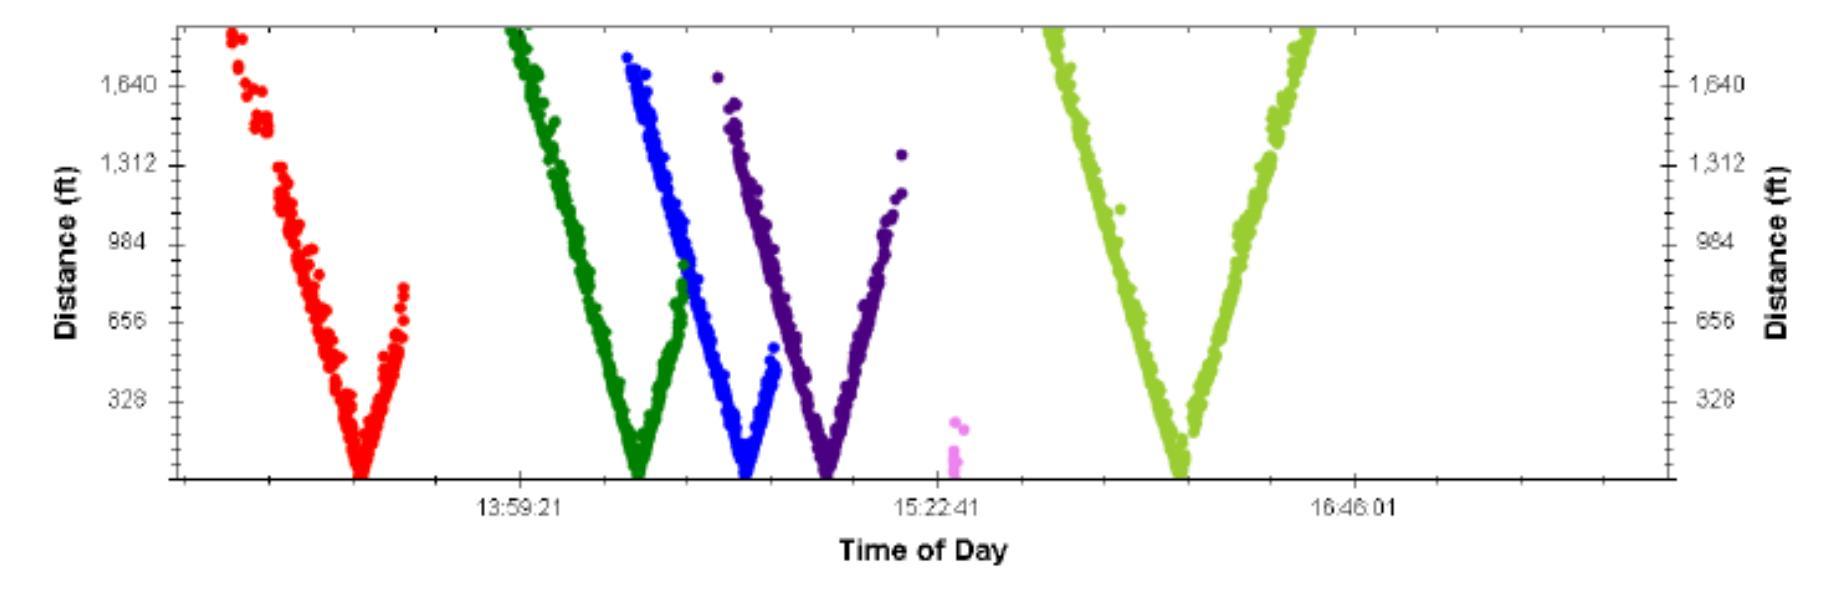
Figure 2.5: Tracking Location Positional Data for the Inspection

Table 2.1: SmartBall Receiver Tracking Locations					
Tracking Location Number	Distance from Insertion [feet]	SmartBall Passage Time [hh:mm:ss]	Location Description	GPS Coordinates	
TL #1	0	12:50:44 PM	Vault STA 239+00 (Insertion)	34.239029, -118.900064	
TL #2	2,530	1:27:44 PM	MH & ARV STA 264+26	34.238098, -118.908331	
TL #3	4,215	1:53:13 PM	Vault STA 281+00	34.237510, -118.913862	
TL #4	6,326	2:23:01 PM	Blowoff STA 302+00	34.236833, -118.920677	
TL #5	7,906	2:44:26 PM	MH & ARV STA 317+75	34.241001, -118.920881	
TL #6	9,138	3:00:47 PM	MH & ARV STA 330+00	34.240935, -118.924954	
TL #7	11,121	3:26:24 PM	Blowoff STA 349+85	34.241422, -118.931471
